Machinery Messages

Case History

Using ADRE® 3 to on a pressurized water

diagnose problems on reactor coolant pump

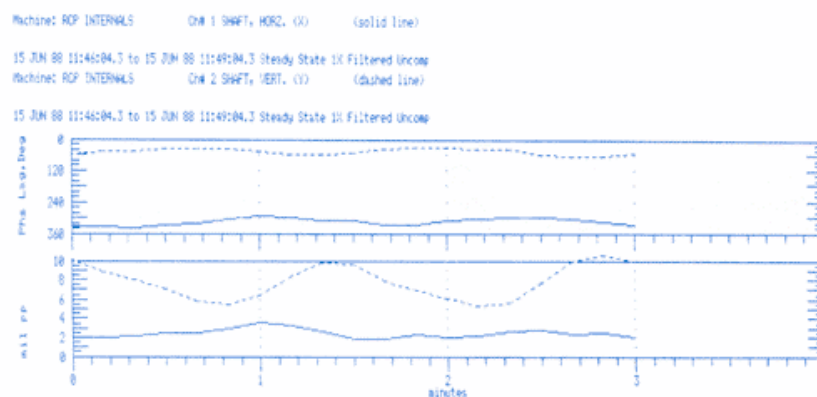
Figure 2

With the 108 DAI, Stan obtained steady state data at plant full power conditions. Using ADRE[®]3 Software, he plotted Bodé, Shaft Centerline and Spectrum plots. From data obtained via the proximity probes, the (APHT) Amplitude & Phase versus Time plots generated (Figure 2) revealed vibration cycling with relatively minor changes in phase angle. The Spectrum plots (Waterfall format,

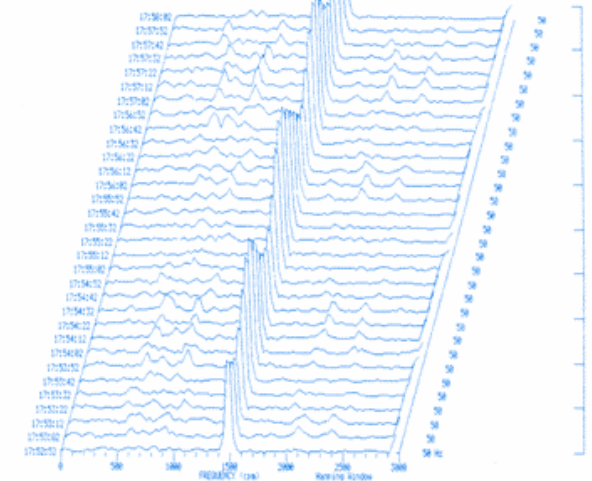
Figure 6

Figure 6) also illustrated the vibration cycling, the presence of submultiple components and multiple components above running speed, but only at certain times during each cycle's period.

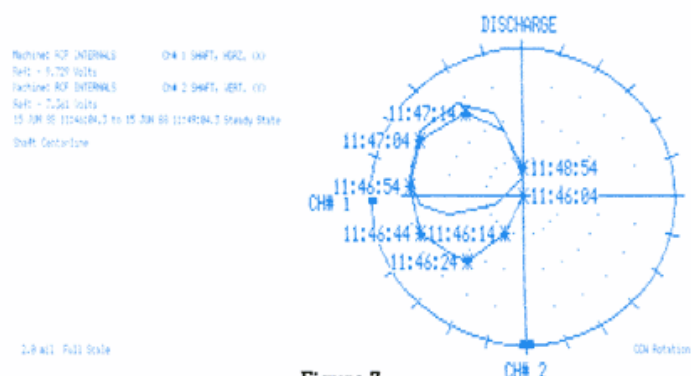
Figure 7

Other plots were more revealing. At steady state conditions, the Shaft Centerline plot (Figure 7) indicated that the shaft was moving radially within the bearing clearance. More importantly, it indicated the variation occurred in a clockwise precession, opposite to the rotational direction of the pump shaft. Seismic transducers mounted on the motor frame revealed little additional information on the nature of the problem.

After seeing the reverse precession direction of the shaft centerline, Stan suspected a rub condition. The unusual pattern of submultiples had hinted that rubbing was a possibility. However, lack of Keyphasor signal jitter and the slow changes in the vibration levels did not fit the traditional ideas of what a rub usually looks like (though they didn't contradict the notion that a rub could still be present). Stan likened this motion to a "lubricated dry rub". A full dry rub produces backwards precession at much higher speed (and usually quickly destroys the machine). This motion is primarily forward spin of the rotor with a small component of torsional drag due to rubbing causing the rotor to precess

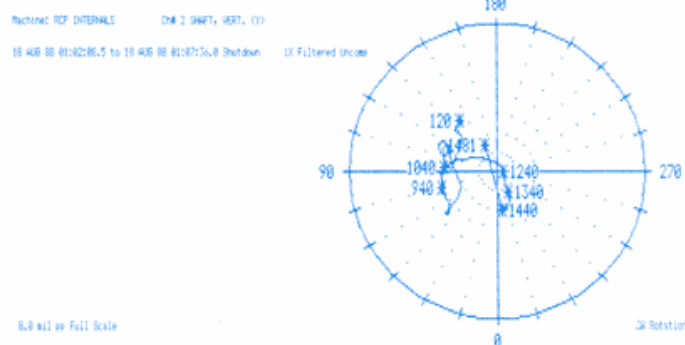
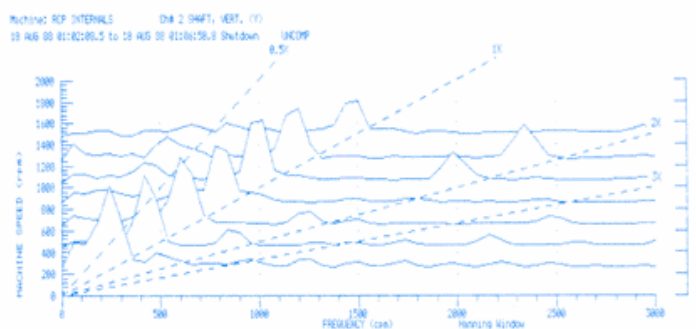
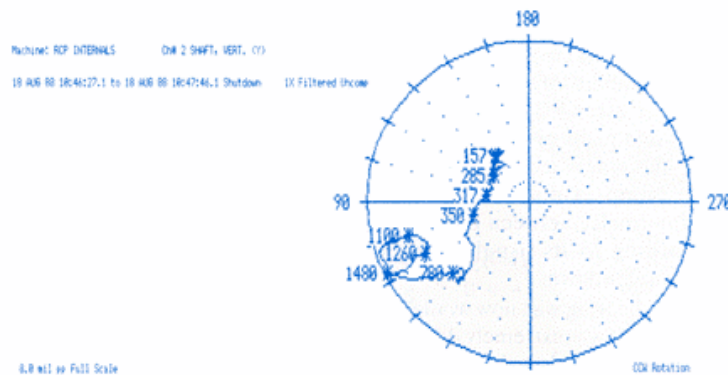
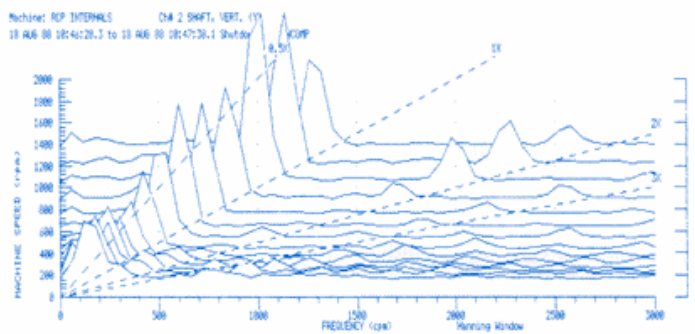
New information obtained affirmed the rub hypothesis and confirmed the explanations which related the oscillating seal flows and cycling vibration to the oscillations in shaft centerline position. Figures 9, 10, 11 and 12 show two coastdowns taken by the ADRE[®]3 equipment in the normal course of data acquisition which appear to have come from two very different machines. Correlation of these plots with the shaft centerline plots (not shown) proved that these two coastdowns were initiated when the shaft centerline positions were almost as far apart as they could be. Vibration amplitudes were also near the extremes of their ranges. Given this data, it was more certain that the variation in dynamic bearing constants was responsible for the oscillation in the amplitude of vibration.
